PRELIMINARY REPORT IN THE MATTER OF:

Lindquist vs HEIM, L.P..

By Gary M. Hutter, Ph.D., P.E., C.S.P.

March 8, 2006

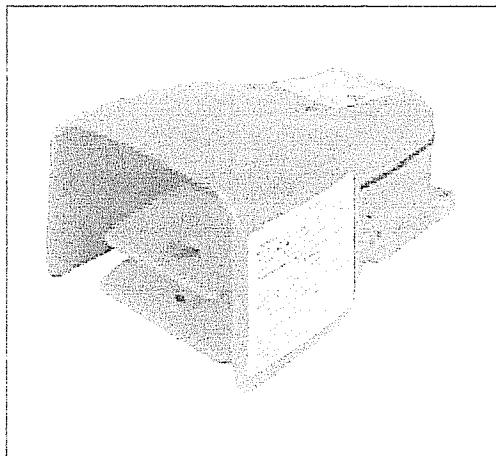
Foot controls are not safeguards because they do not keep the operator's hands out of the danger area. If you use them, they will need some type of guard or device, such as barriers or pullouts with interlocks capable of controlling the start up of the machine cycle. Using foot controls may increase productivity, but the freedom of hand movement allowed while the machine is operating increases the risk of a point of operation injury. Foot controls must be guarded to prevent accidental activation by another worker or by falling material and not allow continuous cycling. They work best when the operator is in a sitting position. Always avoid the hazard of riding the pedal (keeping the foot on the pedal while not actively depressing it.) (See properly guarded and positioned foot control in Figure 22.)

Figure 22. Properly Guarded Foot Control"
